HISTORIC AMERICAN BUILDINGS SURVEY
INVENTORY

2. NAME *Orrin Thompson Mansion*

DATE OR PERIOD *1832*
STYLE *Greek Revival*
ARCHITECT
BUILDER *Orrin Thompson*

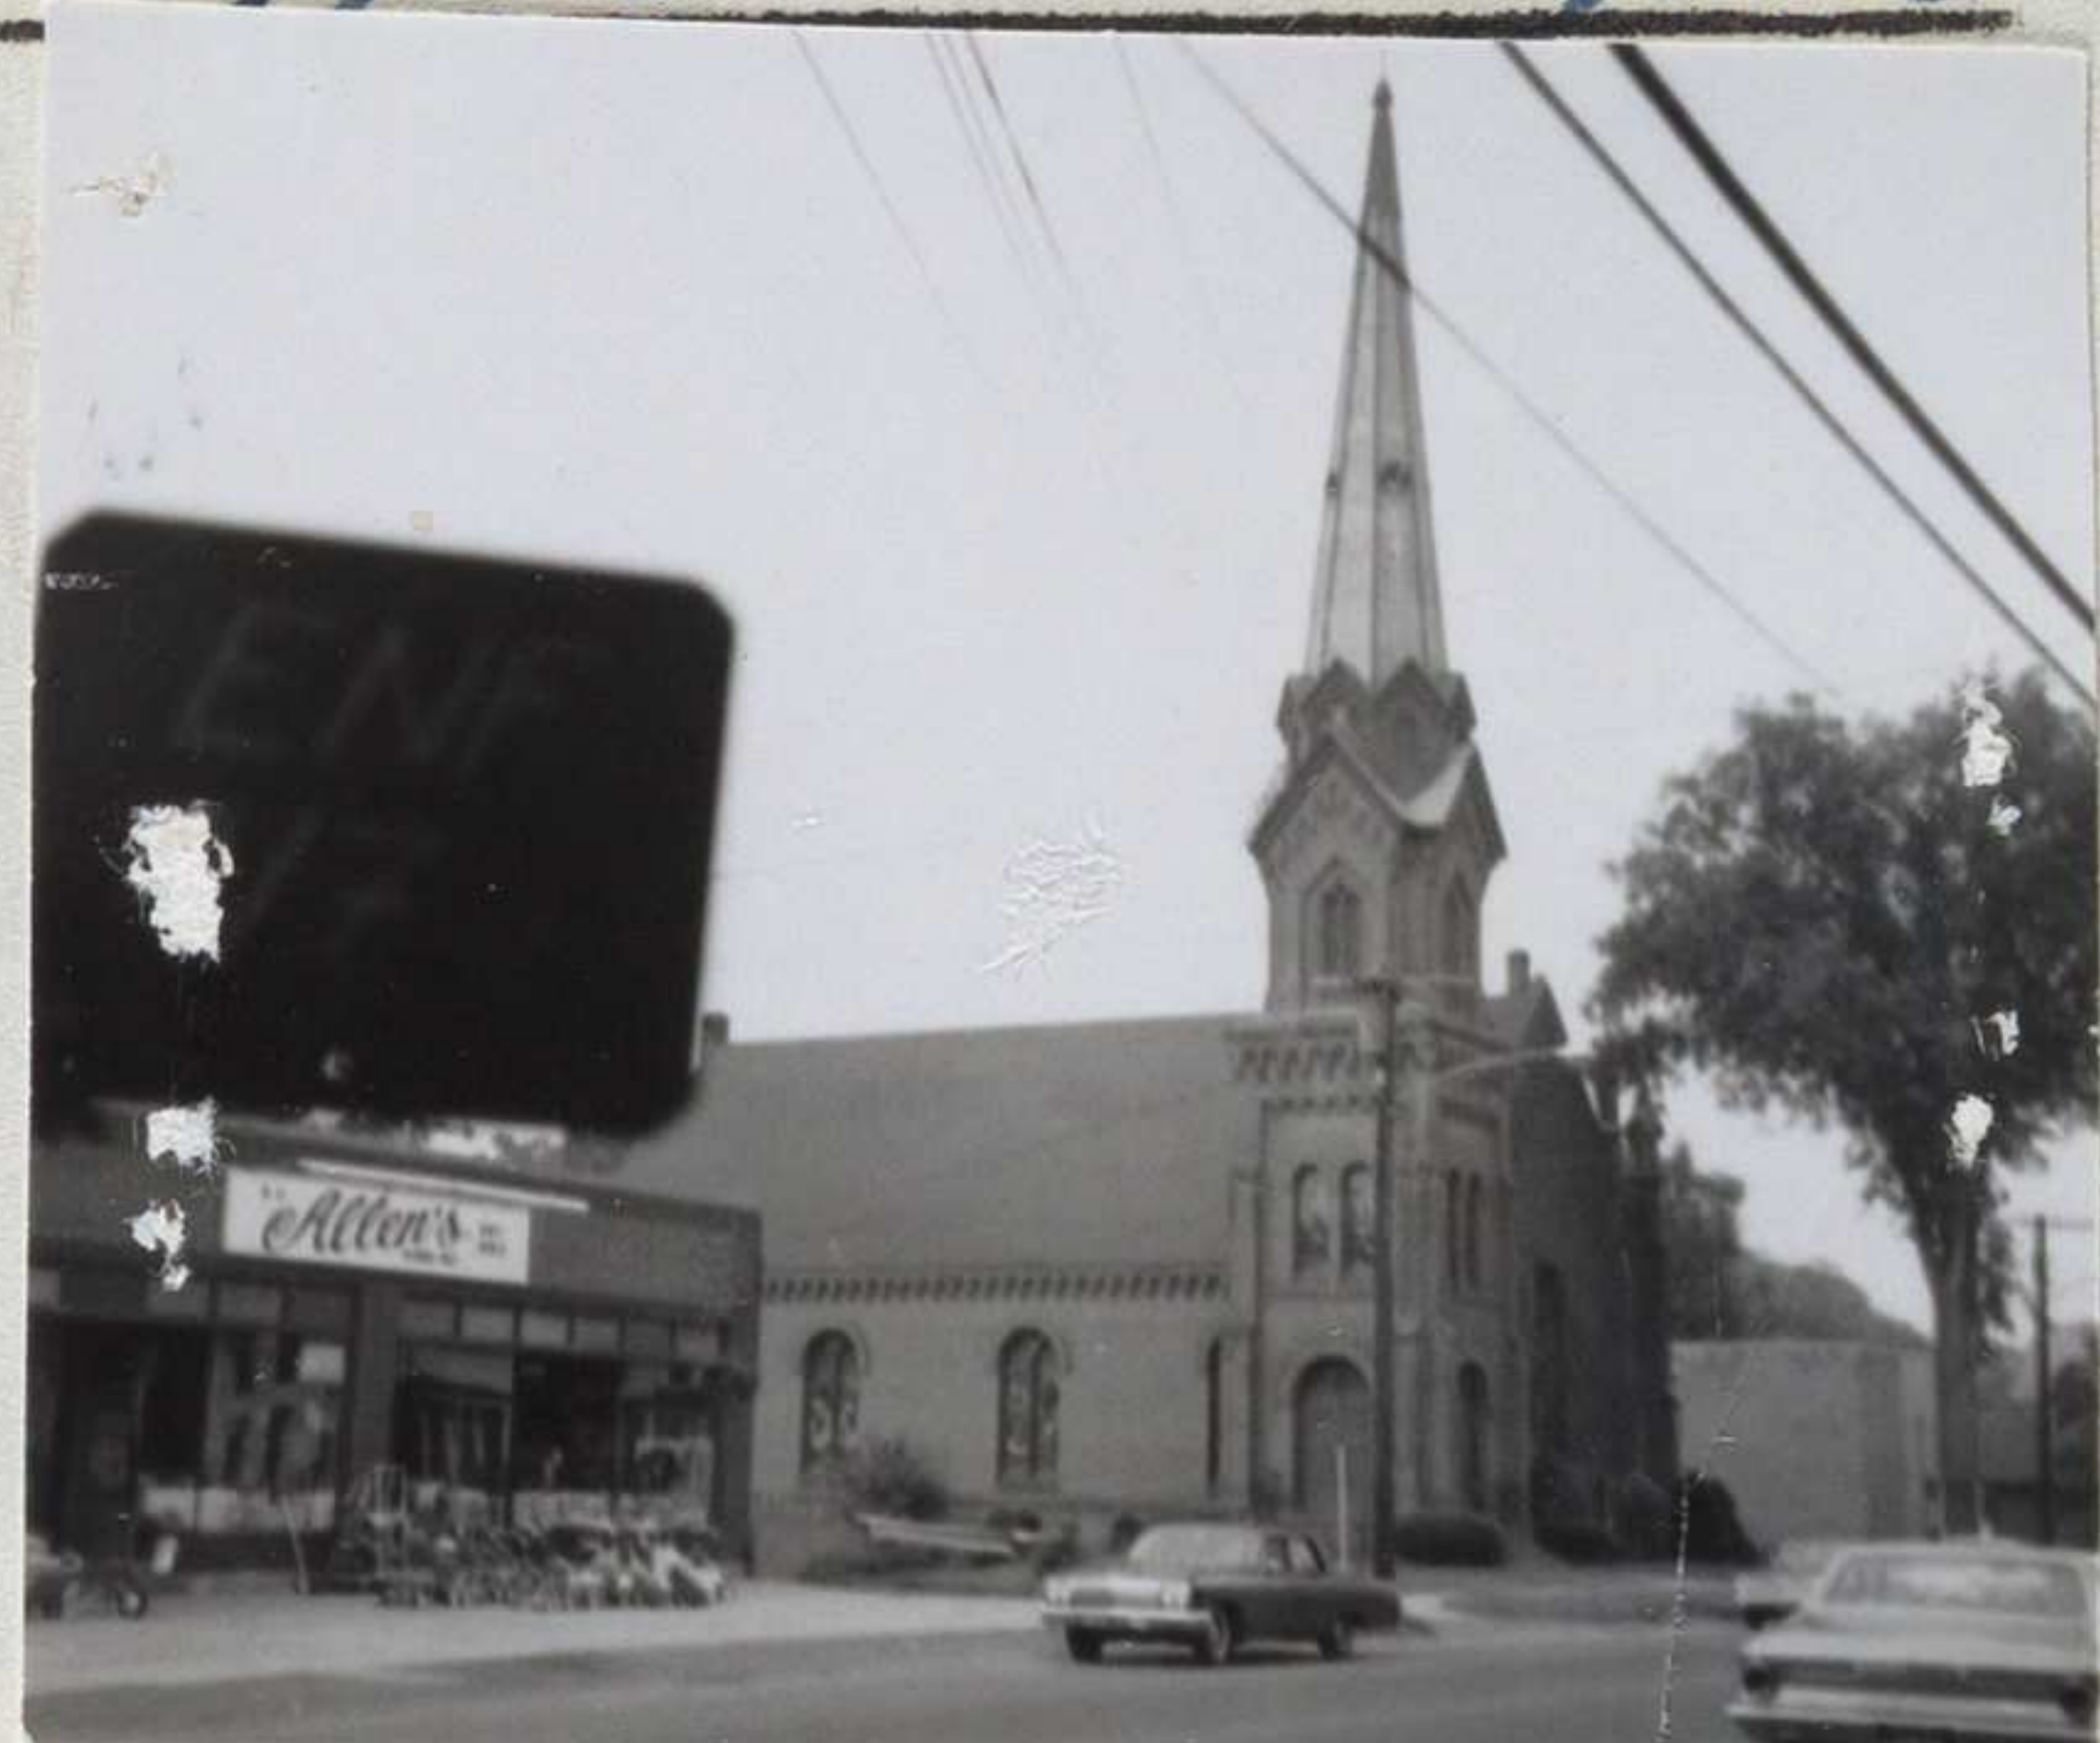
<p>7. PHOTOGRAPH <i>Enf 117</i></p>

<p>1. STATE <i>CT</i> COUNTY <i>Hartford</i> TOWN <i>Enfield</i> VICINITY STREET NO. <i>Main St., Hazardville</i> ORIGINAL OWNER <i>Hazardville Methodist</i> ORIGINAL USE <i>Church</i> PRESENT OWNER <i>Hazrdvl., Meth. Church</i> PRESENT USE <i>Church</i> WALL CONSTRUCTION <i>brick</i> NO. OF STORIES <i>multi.</i></p>		<p>HISTORIC AMERICAN BUILDINGS SURVEY INVENTORY</p> <p>2. NAME <i>Hazardville Methodist Church</i> DATE OR PERIOD <i>1880's</i> STYLE <i>Victorian Gothic</i> ARCHITECT BUILDER</p> <p>3. FOR LIBRARY OF CONGRESS USE</p>			
<p>4. NOTABLE FEATURES, HISTORICAL SIGNIFICANCE AND DESCRIPTION</p> <p><i>This 19th century church is dominated by its octagonal, slate, weather-vaned tower at the N.E. corner, with ovals incised in the design. Three Romanesque arched windows fill out the facade design, the center greatly larger than its fellows. There are five bays to the sides. The corners are decorated with ornamental buttressing and topped with carpenier-Gothic wood pinacles. The walls are elaborately ornamented with brownstone dressings and imaginative brick-work designs are used on the gables and below the eaves. These appear to have been the idea of a local builder since simular designs appear on other buildings.</i></p>		<p>OPEN TO PUBLIC <i>YES</i></p>

<p>5. PHYSICAL CONDITION OF STRUCTURE</p> <p><i>Endangered No Interior good? Exterior good</i></p>		<p>6. LOCATION MAP (Plan Optional)</p>

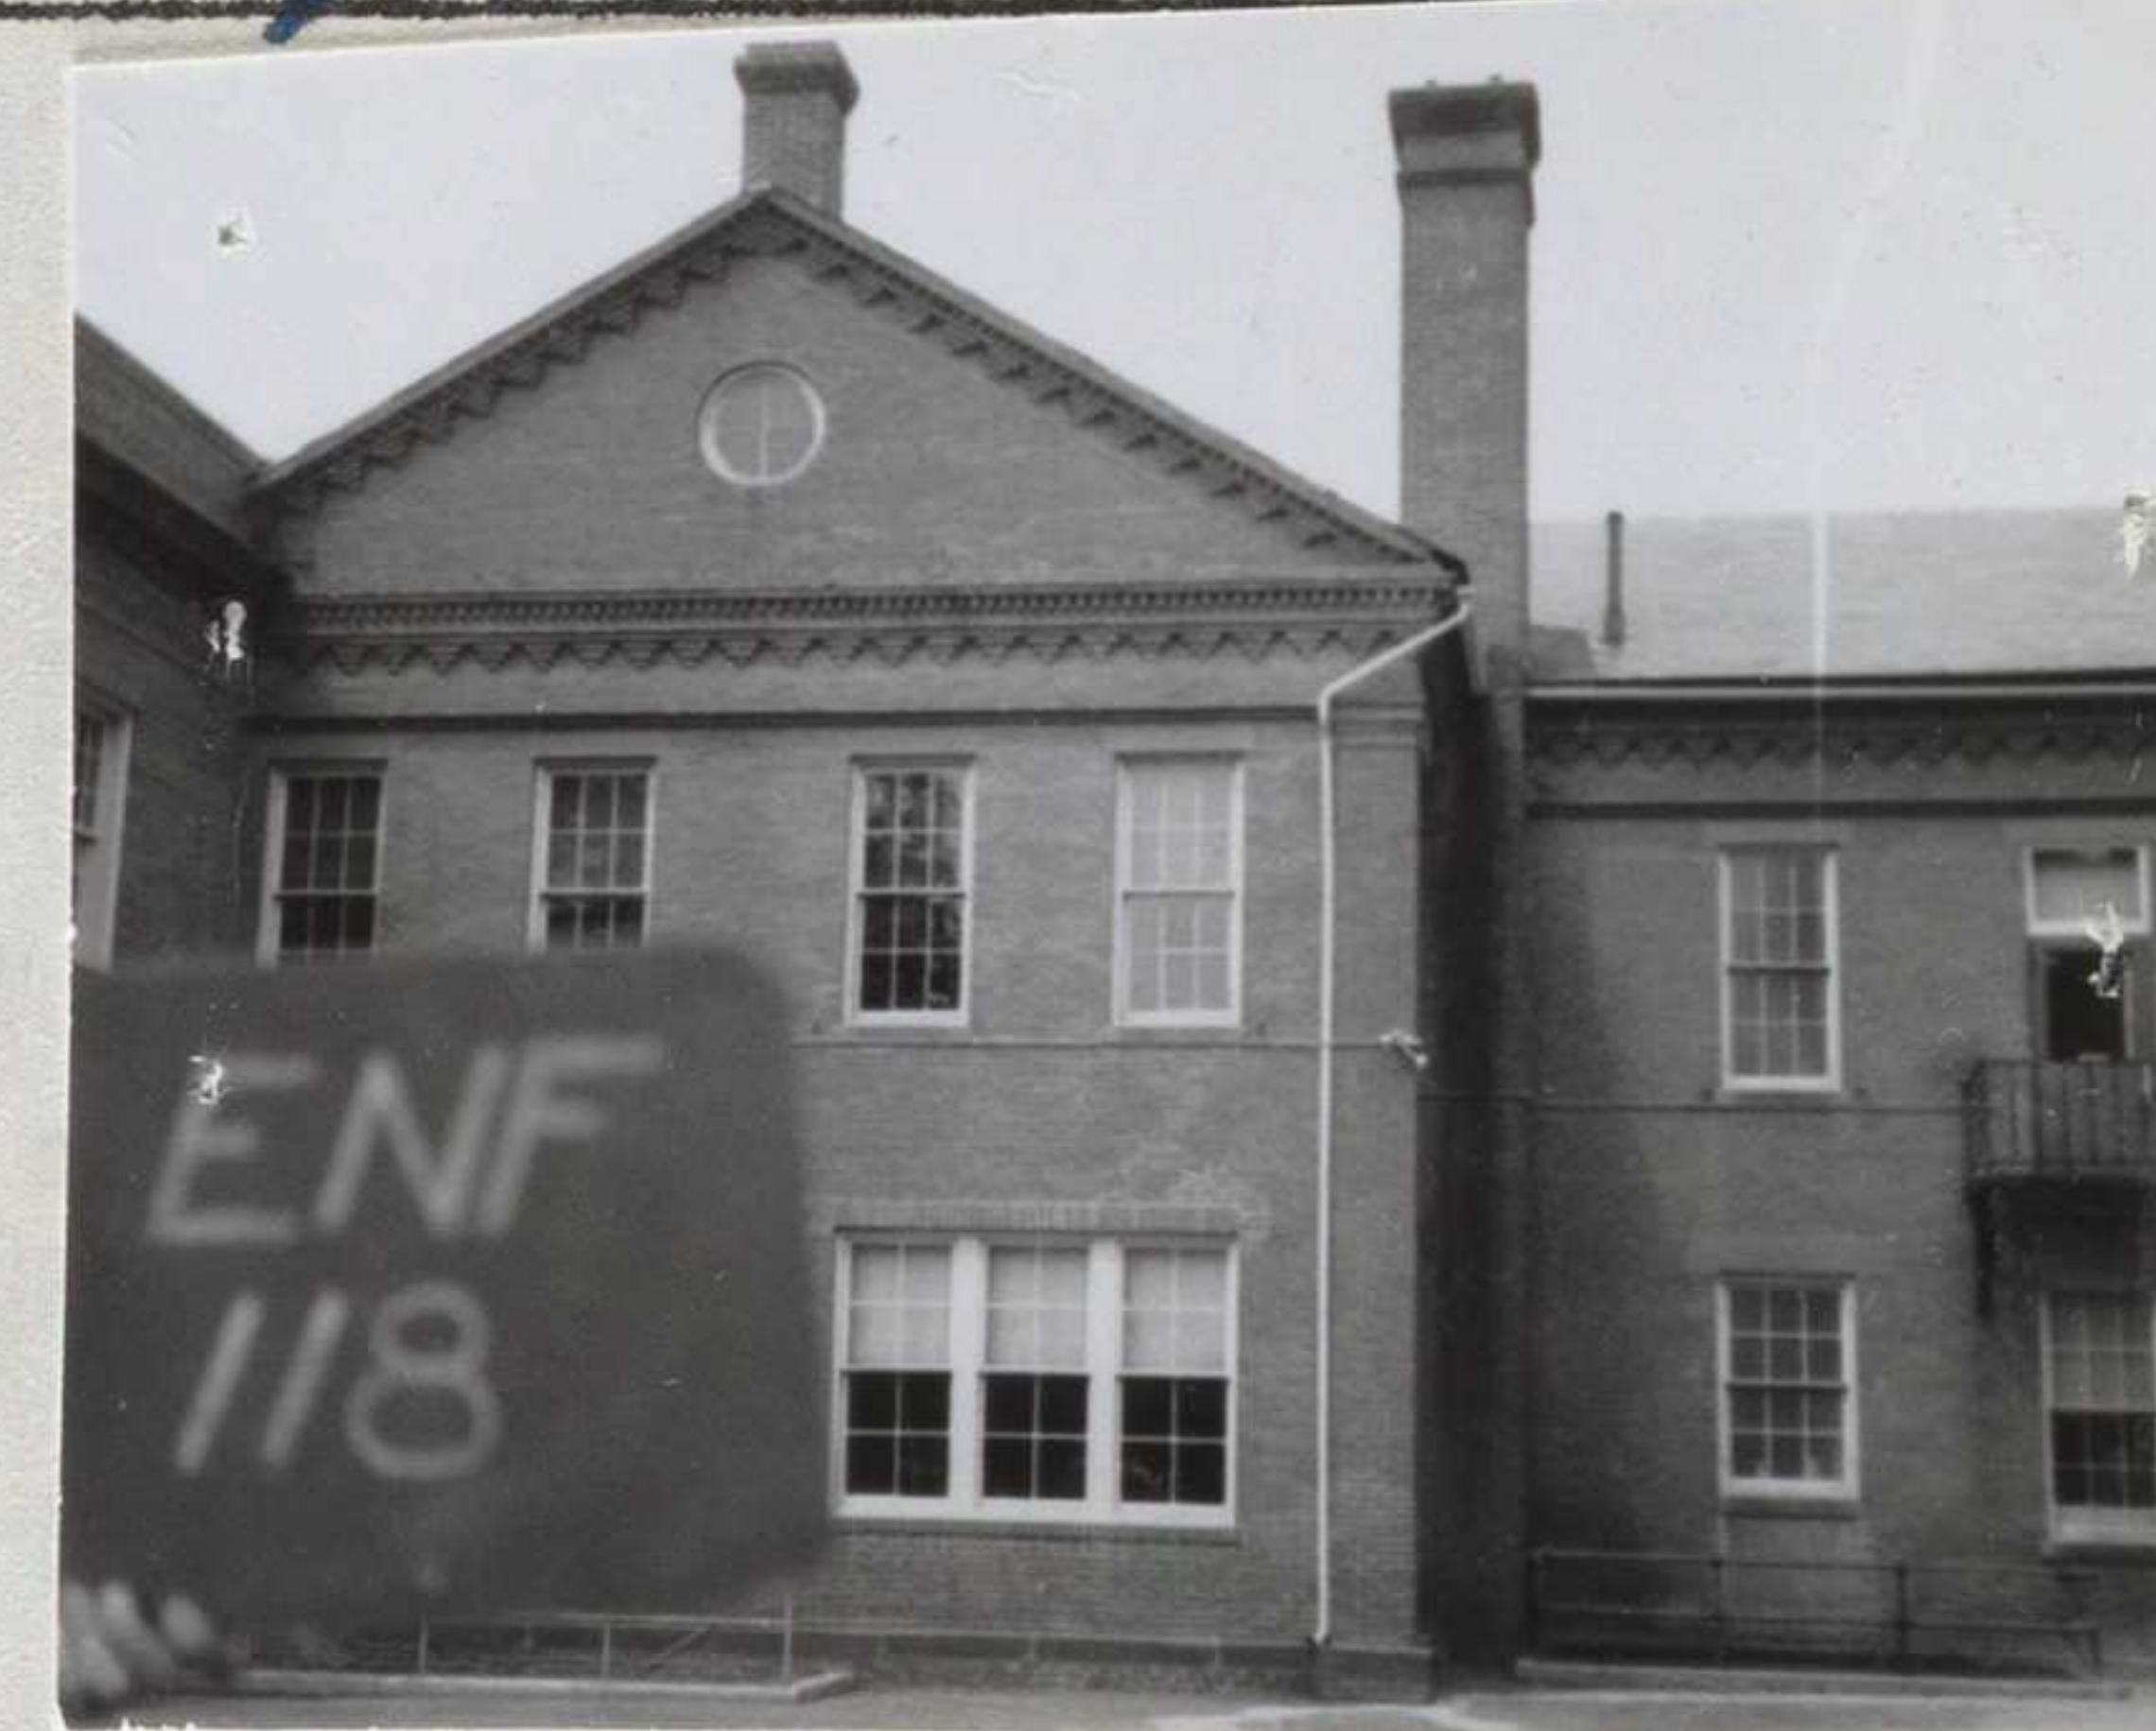
<p>7. PHOTOGRAPH <i>Enf 118</i></p>

<p>1. STATE <i>CT</i> COUNTY <i>Hartford</i> TOWN <i>Enfield</i> VICINITY STREET NO.</p> <p>ORIGINAL OWNER <i>Hazardville</i> ORIGINAL USE <i>School</i> PRESENT OWNER <i>Hazardville</i> PRESENT USE <i>Hazardville Public Rd.</i> WALL CONSTRUCTION <i>brick</i> NO. OF STORIES <i>2</i></p>		<p>HISTORIC AMERICAN BUILDINGS SURVEY INVENTORY</p> <p>2. NAME <i>Hazardville Public School</i> DATE OR PERIOD <i>1880</i> STYLE <i>Neo-Classic Victorian</i> ARCHITECT BUILDER</p> <p>3. FOR LIBRARY OF CONGRESS USE</p>	
<p>4. NOTABLE FEATURES, HISTORICAL SIGNIFICANCE AND DESCRIPTION</p> <p>OPEN TO PUBLIC <i>Yes.</i></p> <p><i>Behind a 20th century street-side addition the old school still shows many of its original forms. The facade is gone but to each section there are 4 bay pedimental sides formed by shallow roofs. Those windows that remain of the original fabric are 4/6 and have brownstone lintels and sills. The walls are of brick with the same inventive projections as seen in the Methodist Church. The roof is of slate.</i></p>

<p>5. PHYSICAL CONDITION OF STRUCTURE</p> <p>Endangered <i>No</i> Interior <i>poor?</i> Exterior <i>fair</i></p>			
<p>6. LOCATION MAP (Plan Optional)</p>

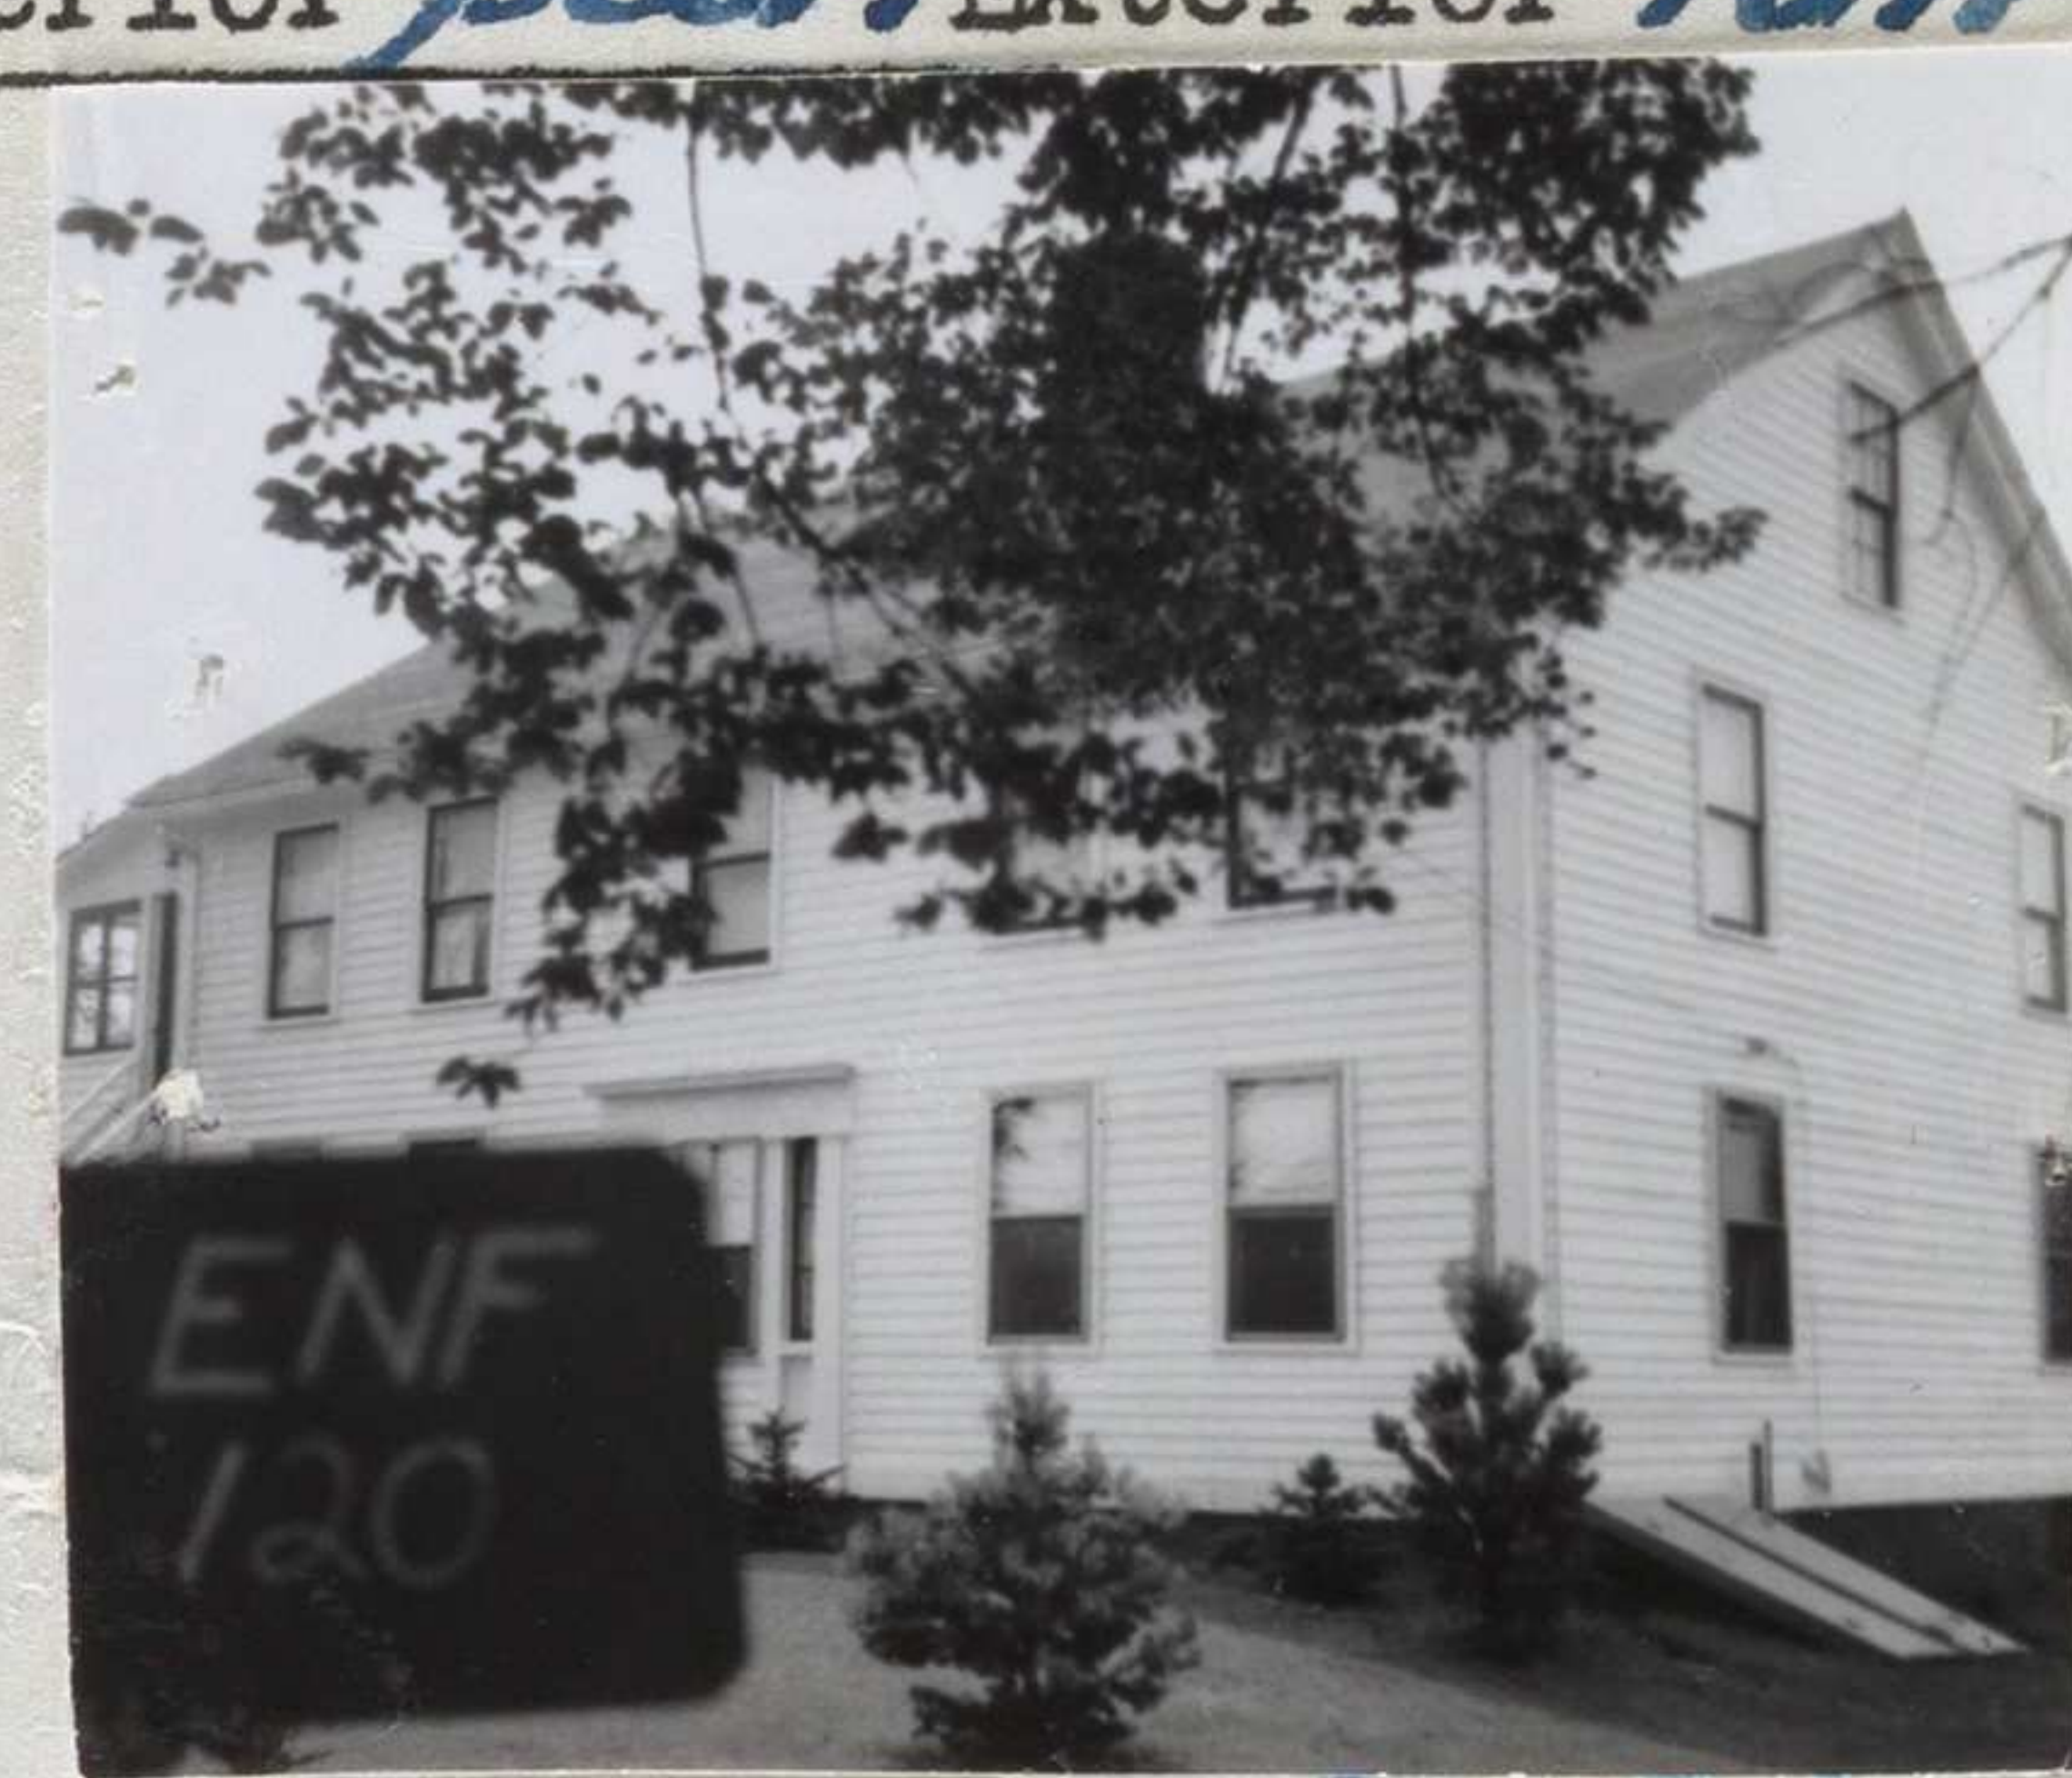
<p>7. PHOTOGRAPH <i>Enf 120</i></p>

<p>1. STATE <i>CT</i> COUNTY <i>Hartford</i> TOWN <i>Enfield</i> VICINITY STREET NO. <i>Main Street (H3rdvl)</i> ORIGINAL OWNER ? ORIGINAL USE <i>Residence</i> PRESENT OWNER ? PRESENT USE <i>Residence</i> WALL CONSTRUCTION <i>clapboard</i> NO. OF STORIES <i>2</i></p>		<p>HISTORIC AMERICAN BUILDINGS SURVEY INVENTORY</p> <p>2. NAME DATE OR PERIOD <i>pre 1800?</i> STYLE <i>Georgian Colonial</i> ARCHITECT BUILDER</p> <p>3. FOR LIBRARY OF CONGRESS USE</p>		
<p>4. NOTABLE FEATURES, HISTORICAL SIGNIFICANCE AND DESCRIPTION</p> <p><i>Capped with a shallow pitched roof and central chimney, this five bay house is built on a brownstone foundation. The windows except from the for a 6/6 in the attic are run original and a door has now been made into a window.</i></p>		<p>OPEN TO PUBLIC <i>No</i></p>		
<p>5. PHYSICAL CONDITION OF STRUCTURE</p> <p><i>Endangered No Interior poor? Exterior fair</i></p>		<p>6. LOCATION MAP (Plan Optional)</p>

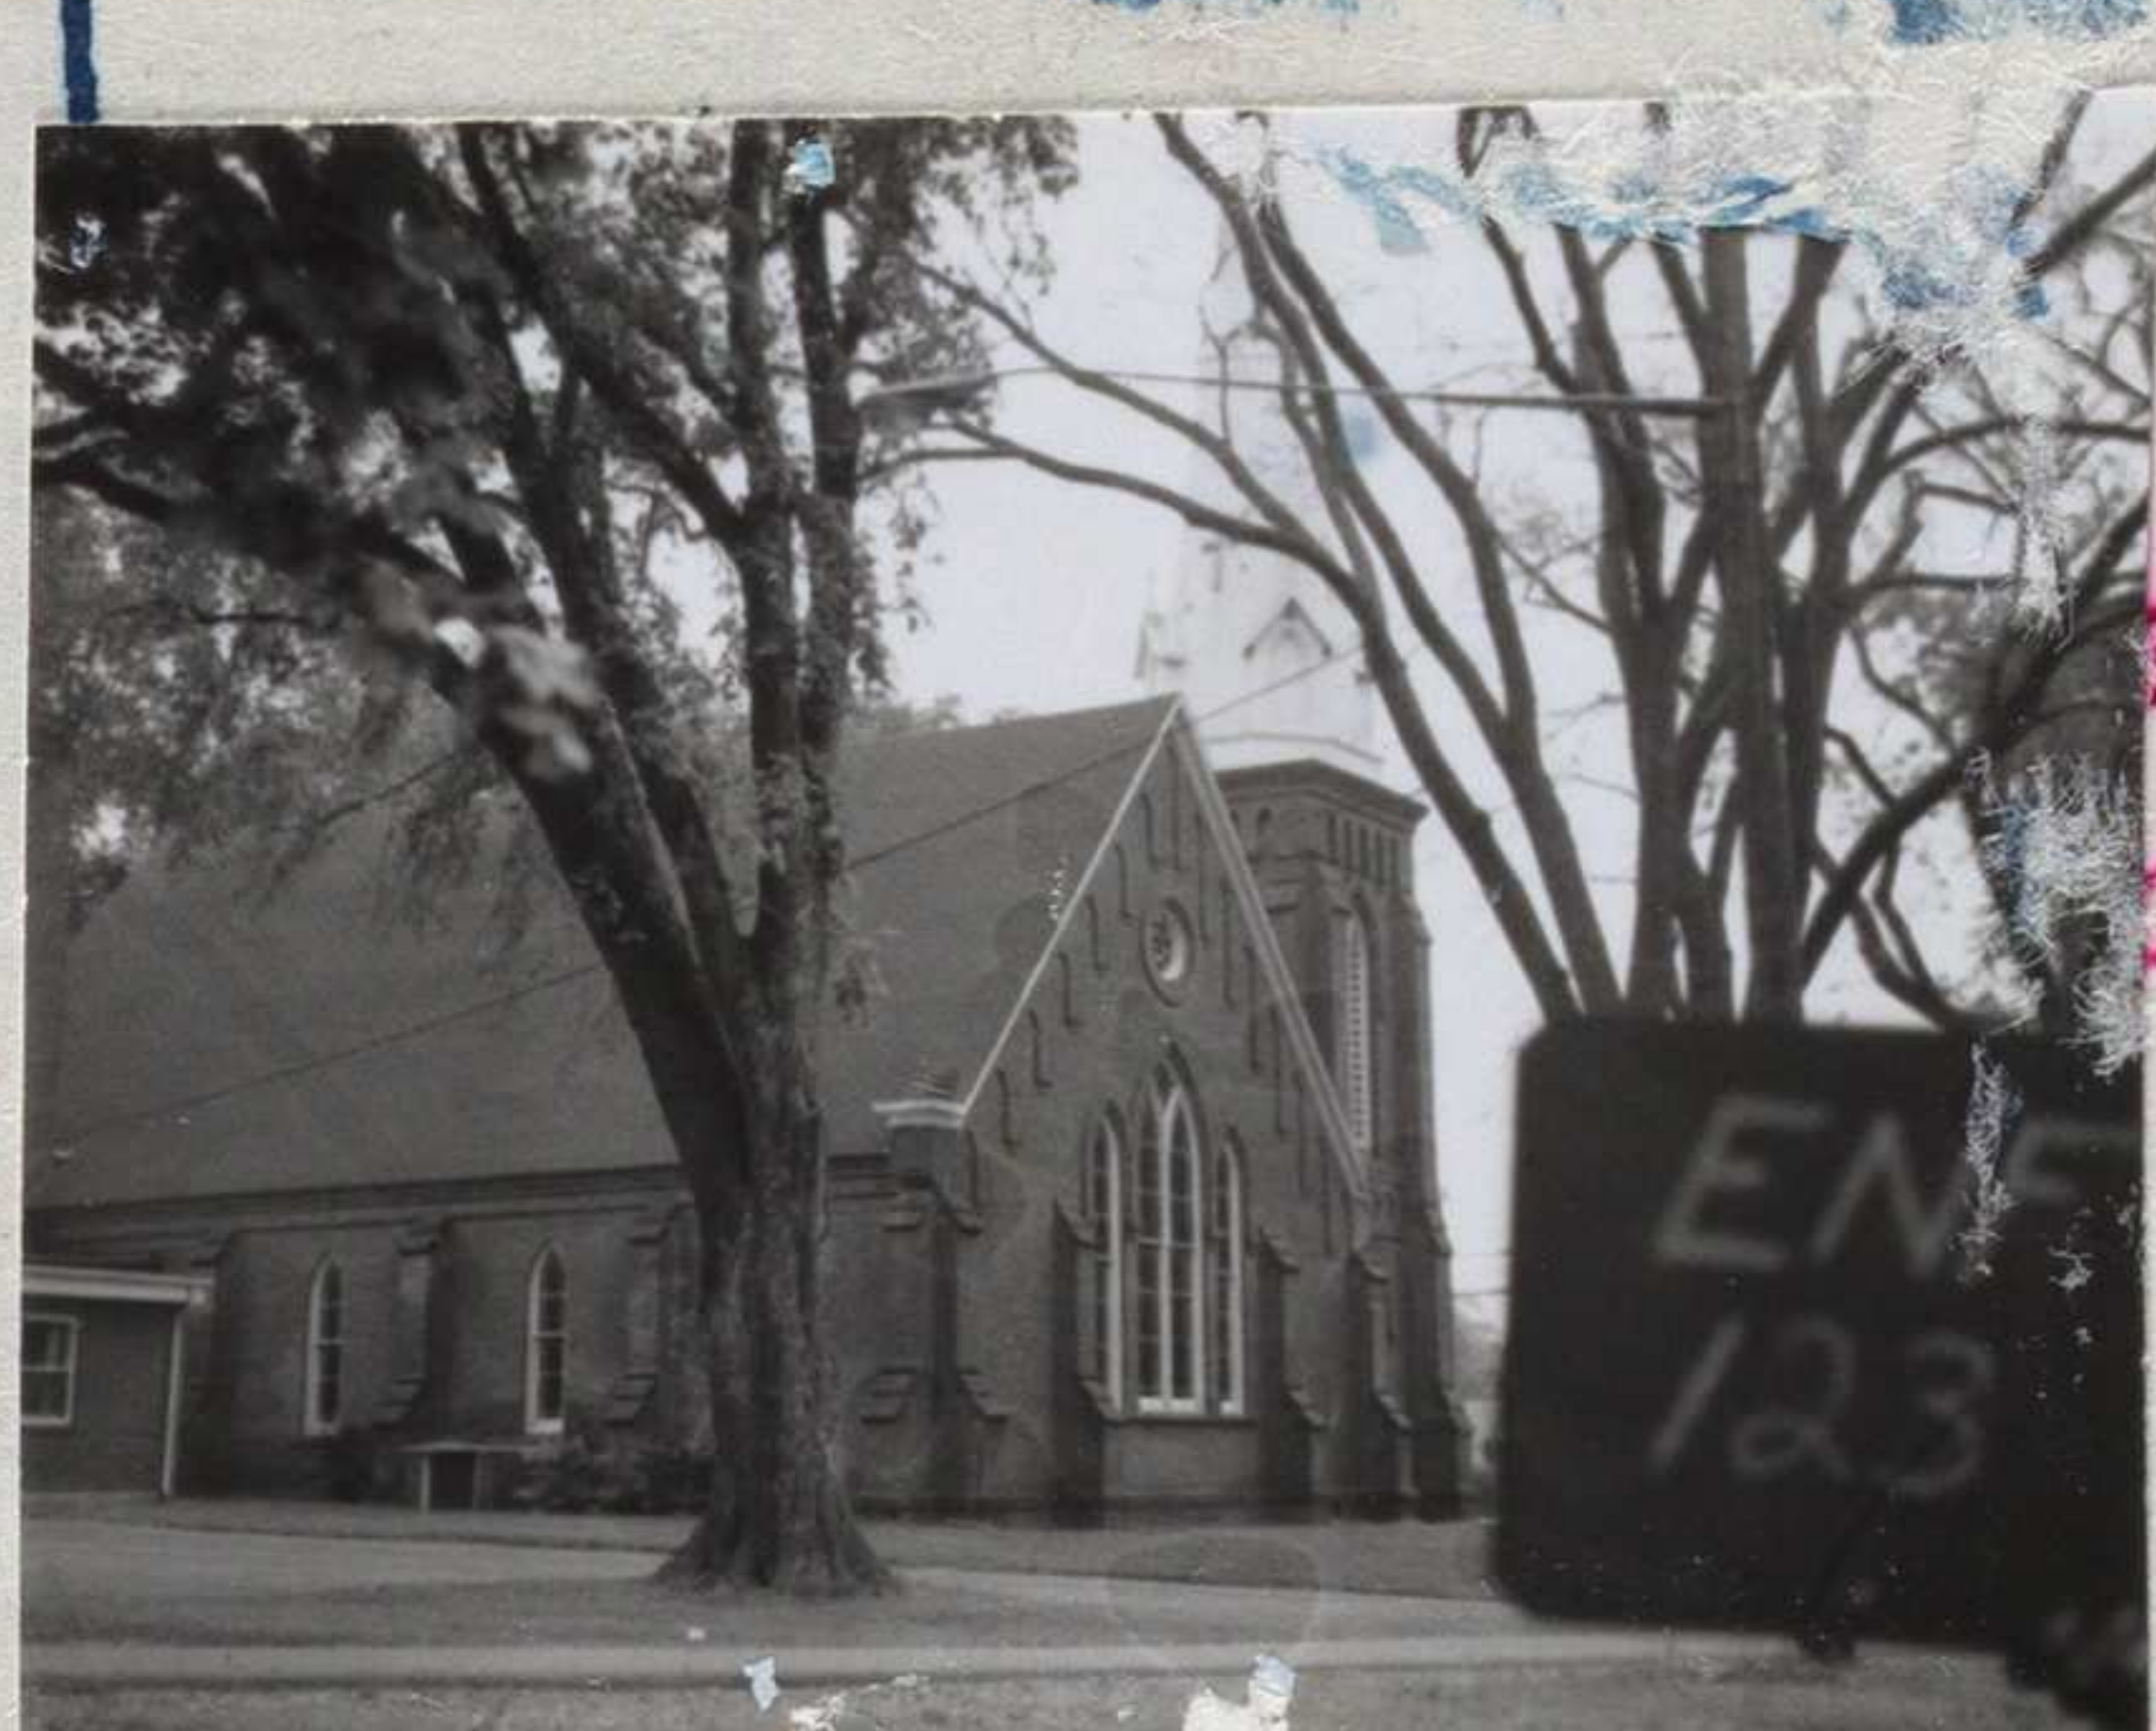
<p>7. PHOTOGRAPH</p>

<p>1. STATE <i>Ct</i> COUNTY <i>Hartford</i> TOWN <i>Hartford</i> VICINITY STREET NO. <i>Main St. (Hazardville)</i> ORIGINAL OWNER <i>Episcopal Church</i> ORIGINAL USE <i>Church</i> PRESENT OWNER <i>Episcopal Church</i> PRESENT USE <i>Church</i> WALL CONSTRUCTION <i>brick</i> NO. OF STORIES <i>one</i></p>		<p>HISTORIC AMERICAN BUILDINGS SURVEY INVENTORY</p> <p>2. NAME <i>Episcopal Church</i> DATE OR PERIOD <i>Victorian</i> STYLE <i>1870</i> ARCHITECT BUILDER <i>Episcopal Church</i></p> <p>3. FOR LIBRARY OF CONGRESS USE</p>	
<p>4. NOTABLE FEATURES, HISTORICAL SIGNIFICANCE AND DESCRIPTION</p> <p><i>It is the multi-story SW corner tower of this church which is its identifying feature. This has spire of wood shingles with cut out crosses and trifolts at various stages. Its sanctuary being to the East the street side has five nave bays with gothic pointed windows. Built on a brownstone foundation the church is mainly of brick with brownstone dressings, particularly at the various stages of its decorative buttresses. The roof which was no doubt originally of slate is of a the steep pitch.</i></p>		<p>OPEN TO PUBLIC <i>No</i></p>

<p>5. PHYSICAL CONDITION OF STRUCTURE</p> <p>Endangered <i>No</i> Interior <i>good</i> Exterior <i>good</i></p>			
<p>6. LOCATION MAP (Plan Optional)</p>

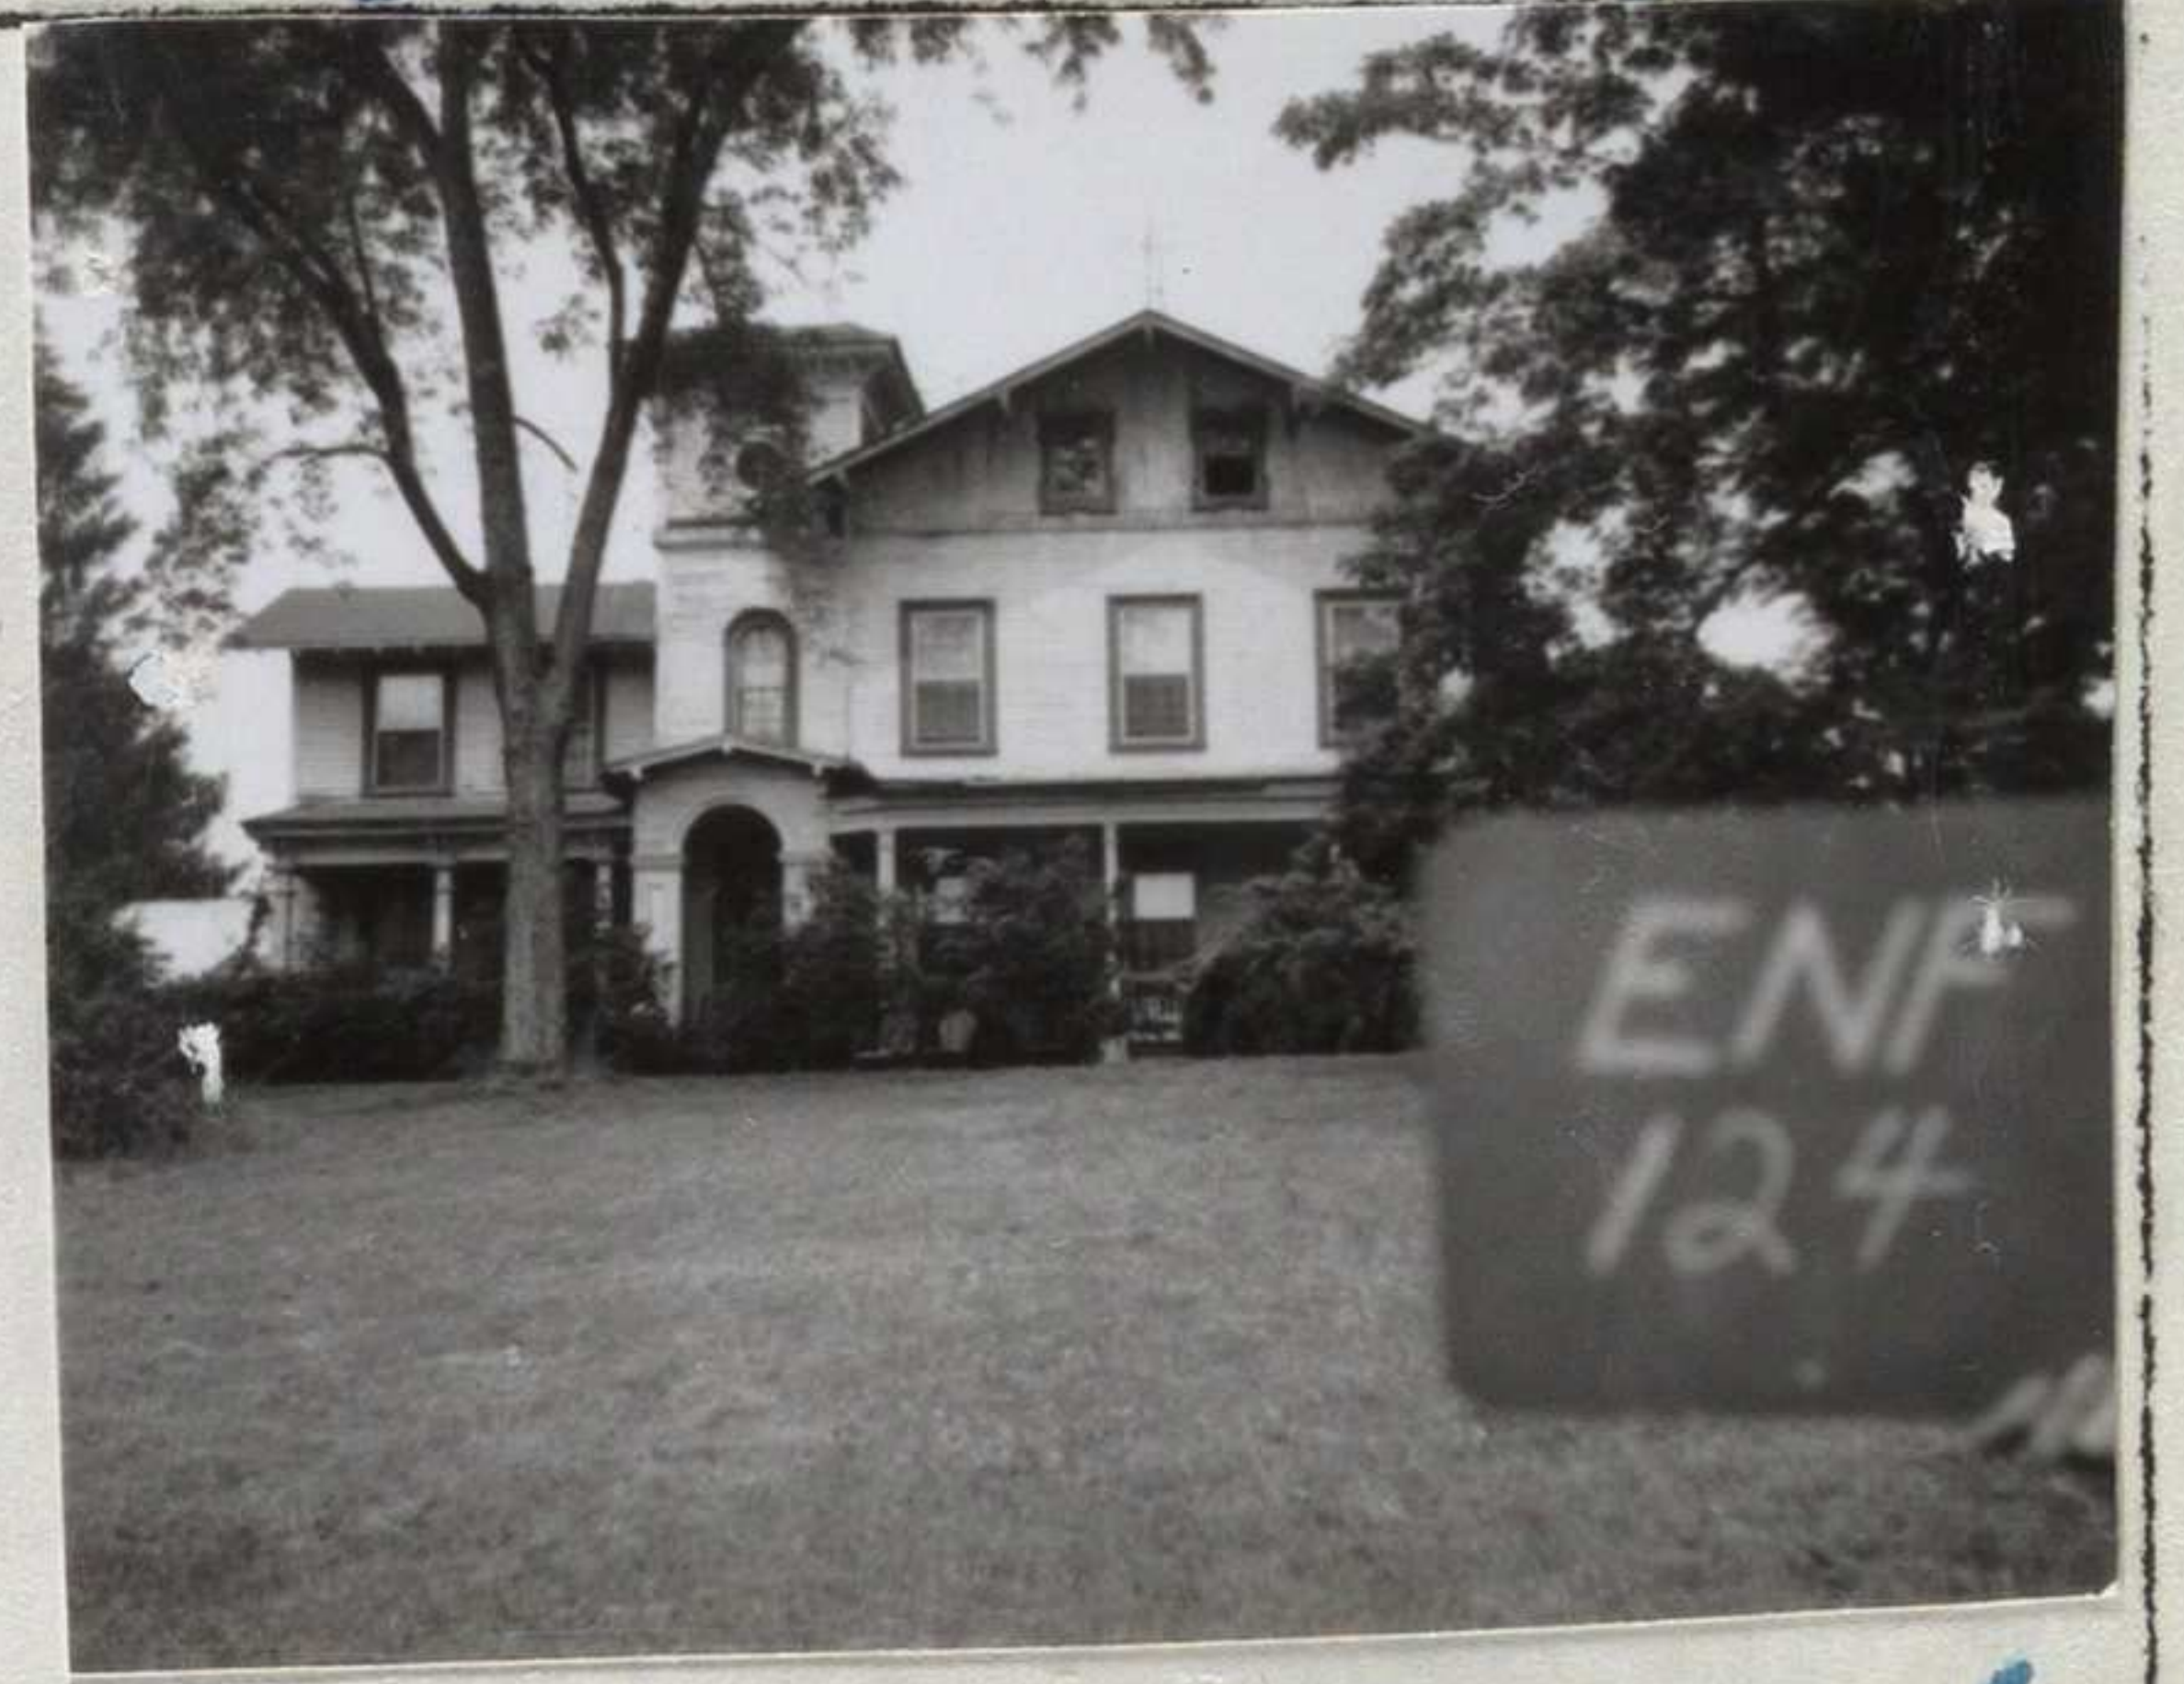
<p><i>Enf 124</i></p>
<p>8. PUBLISHED SOURCES (Author, Title, Pages) INTERVIEWS, RECORDS, PHOTOS, ETC.</p>		<p>9. NAME, ADDRESS AND TITLE OF RECORDER</p> <p><i>Eric J. Endersby</i> <i>Eric J. Endersby</i></p> <p>DATE OF RECORD <i>7/18/67</i></p>

<p>1. STATE <i>CT</i> COUNTY <i>Hartford</i> TOWN <i>Enfield</i> VICINITY STREET NO. <i>Main Street</i> ORIGINAL OWNER : ORIGINAL USE <i>Residence</i> PRESENT OWNER : PRESENT USE <i>Residence</i> WALL CONSTRUCTION <i>clapboard</i> NO. OF STORIES <i>2 1/2</i></p>		<p>HISTORIC AMERICAN BUILDINGS SURVEY INVENTORY</p> <p>2. NAME DATE OR PERIOD <i>1865-1870?</i> STYLE <i>Italian Villa - Chalet</i> ARCHITECT BUILDER</p> <p>3. FOR LIBRARY OF CONGRESS USE</p>		
<p>4. NOTABLE FEATURES, HISTORICAL SIGNIFICANCE AND DESCRIPTION</p> <p><i>This 19th century house cannot exactly be called Italian villa style, since instead of a mansard roof there is a very wide projecting eave of shallow pitch resembling that of a chalet; another paradox of 19th century architecture. This main section is in three bays on the first two floors, two in the high attic story. To the immediate east is a campanile-type tower housing the round-headed door and portico, arched 2nd story windows, and round window on the third. A two story wing extends further to the East. The windows elsewhere on the primary floors are 6/6. Plain boarding is the wall construction.</i></p>		<p>OPEN TO PUBLIC <i>No</i></p>

<p>5. PHYSICAL CONDITION OF STRUCTURE</p> <p><i>Endangered ? Interior fair Exterior good</i></p>		<p>6. LOCATION MAP (Plan Optional)</p>

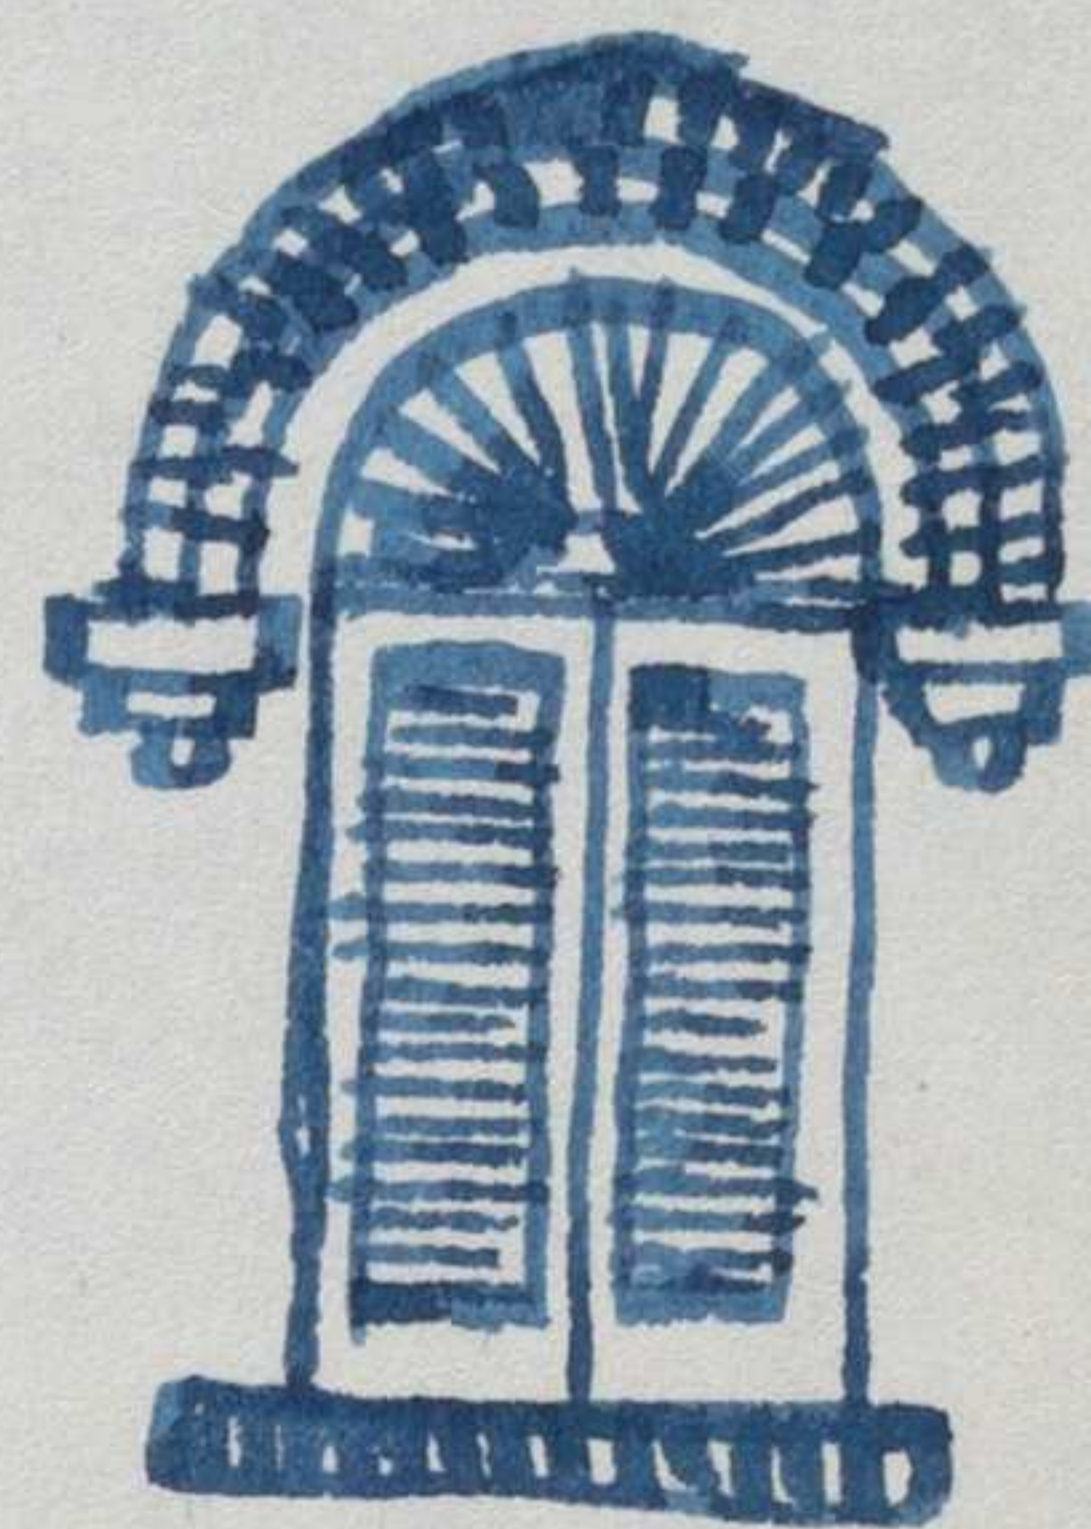
attic windows

This grand T-shaped house is built on a brownstone foundation. There is a shallow pitched roof which is supported by pilasters and entablature ingeniously formed of brick. The Enfield Street pediment has an arch topped window with shutters and fan louvered top. The other windows are 6/6 with brownstone sills and lintels. The South side door is original and framed in a transom and sidelights. Along this same side is magnificent Philadelphia cast iron two story porch of the grape pattern so popular in New Orleans.
